April 24, 2018 (Revised June 8, 2018)

For: Meher Archive Collective, (MAC)  
Asheville, North Carolina

## FEASIBILITY ANALYSIS SUMMARY

### SUMMARY OF SUITABILITY OF 53 RED OAK SCHOOL ROAD PROPERTY FOR MAC COLLECTIVE

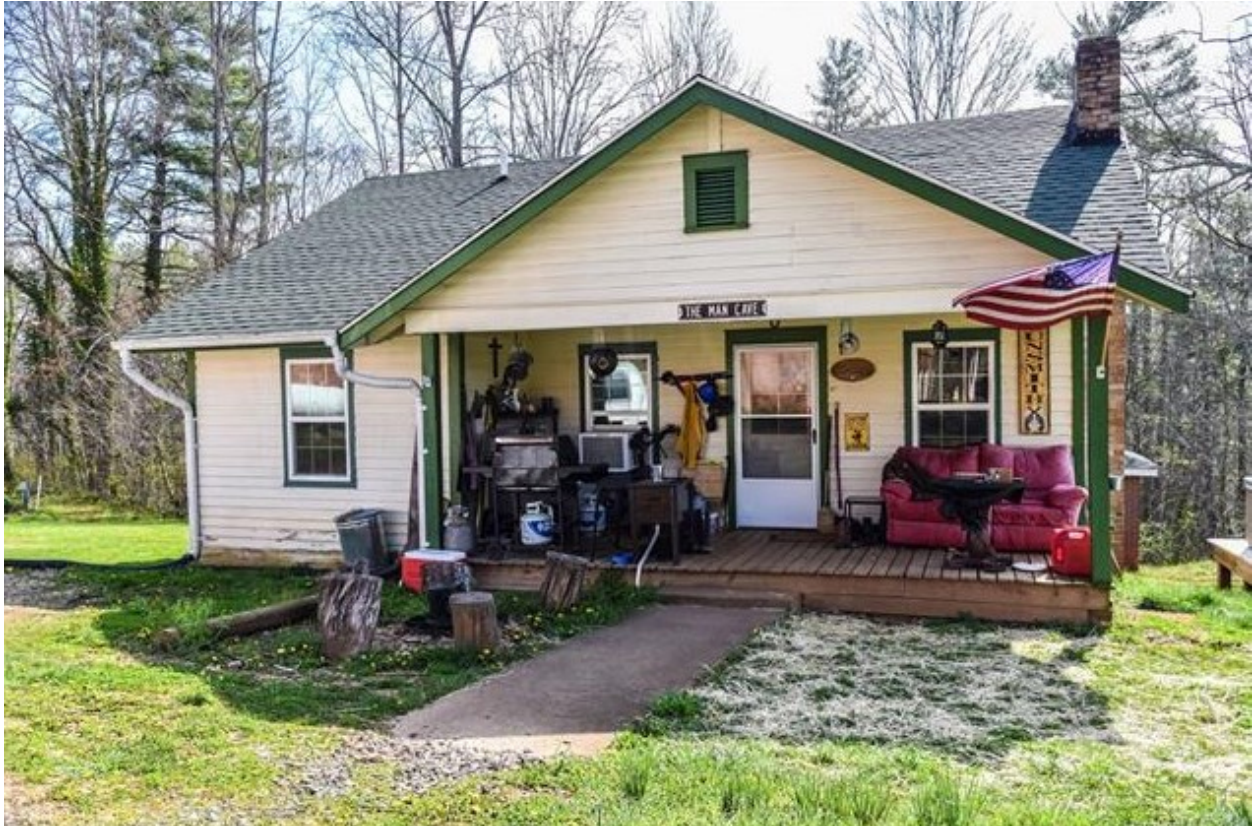
1.10 The property includes a small two bedroom wood framed home that presently serves as a caretaker's cabin. It is in reasonable condition with a new roof.

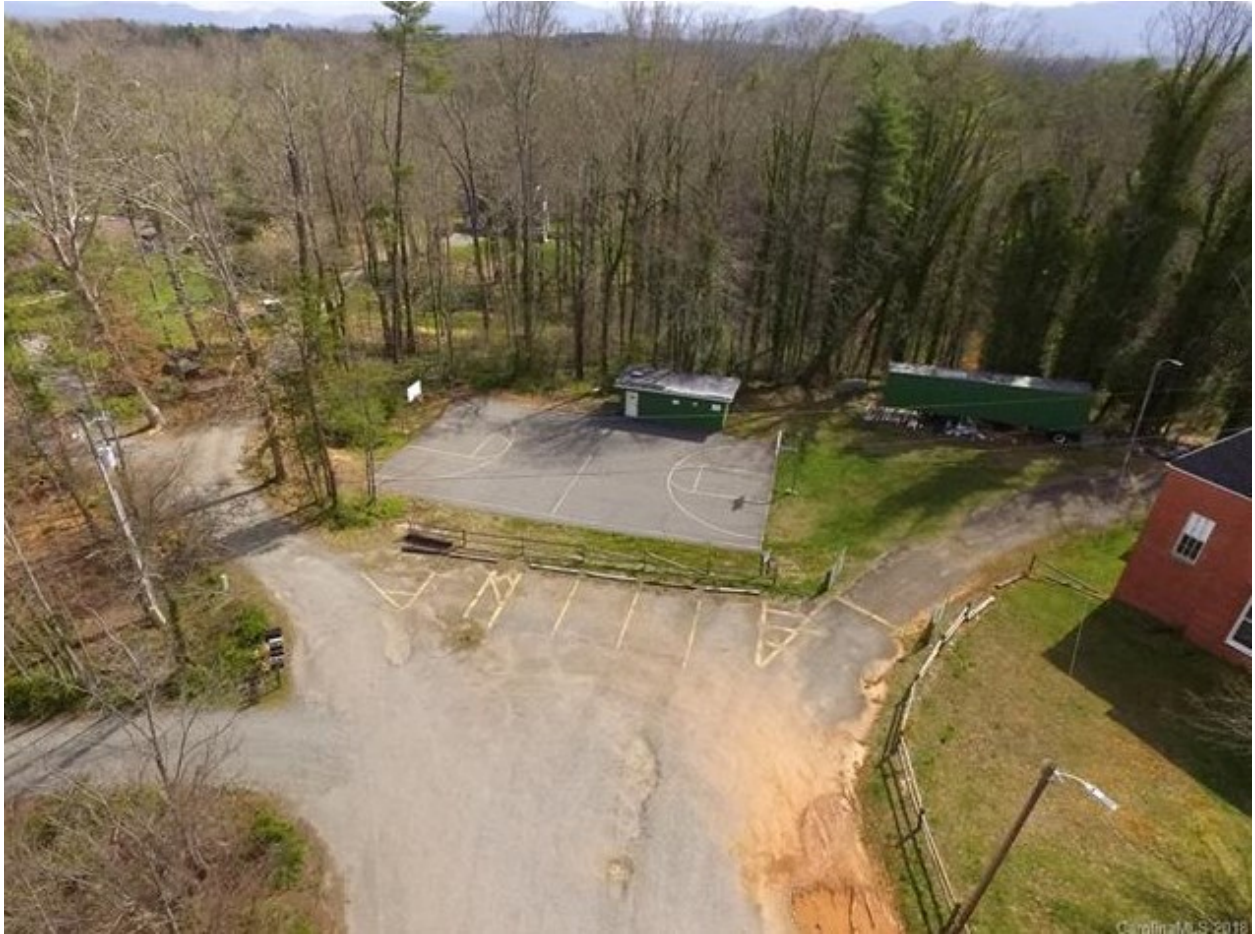
1.11 There is an outdoor basketball court that could service overflow parking.

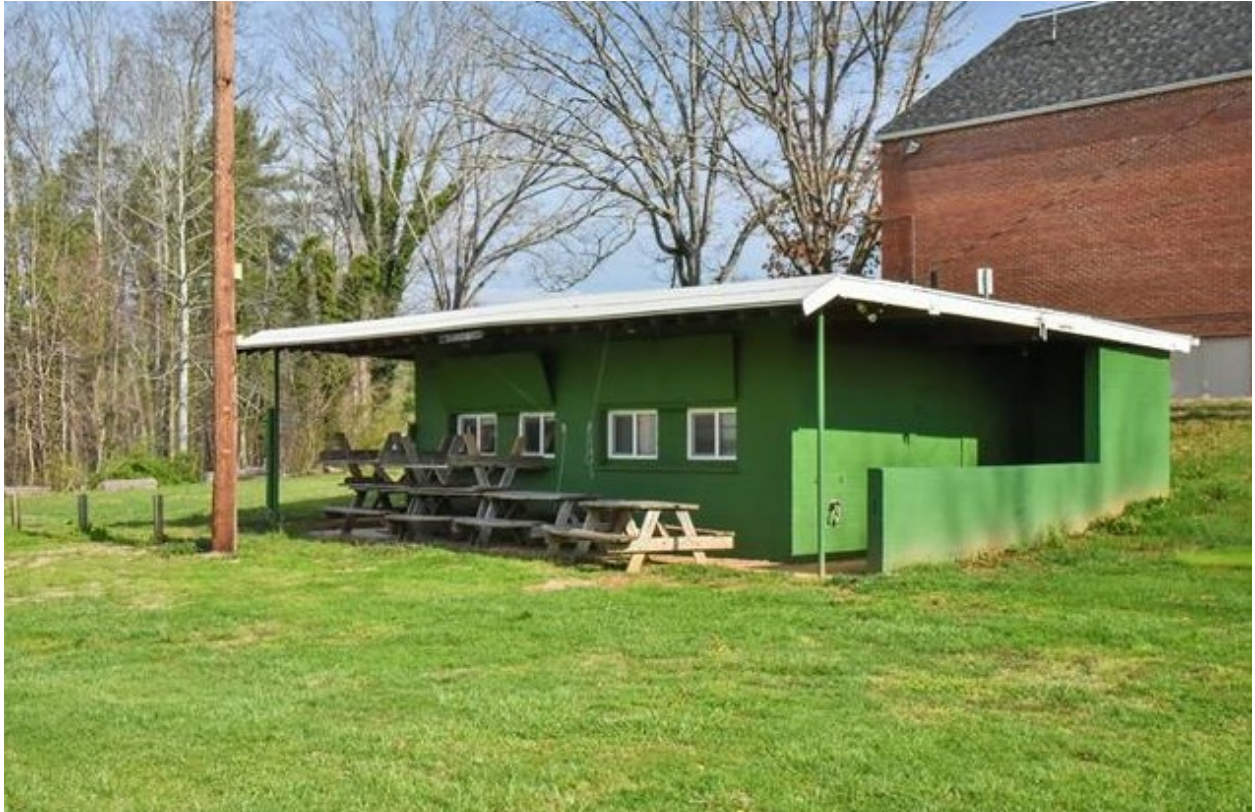
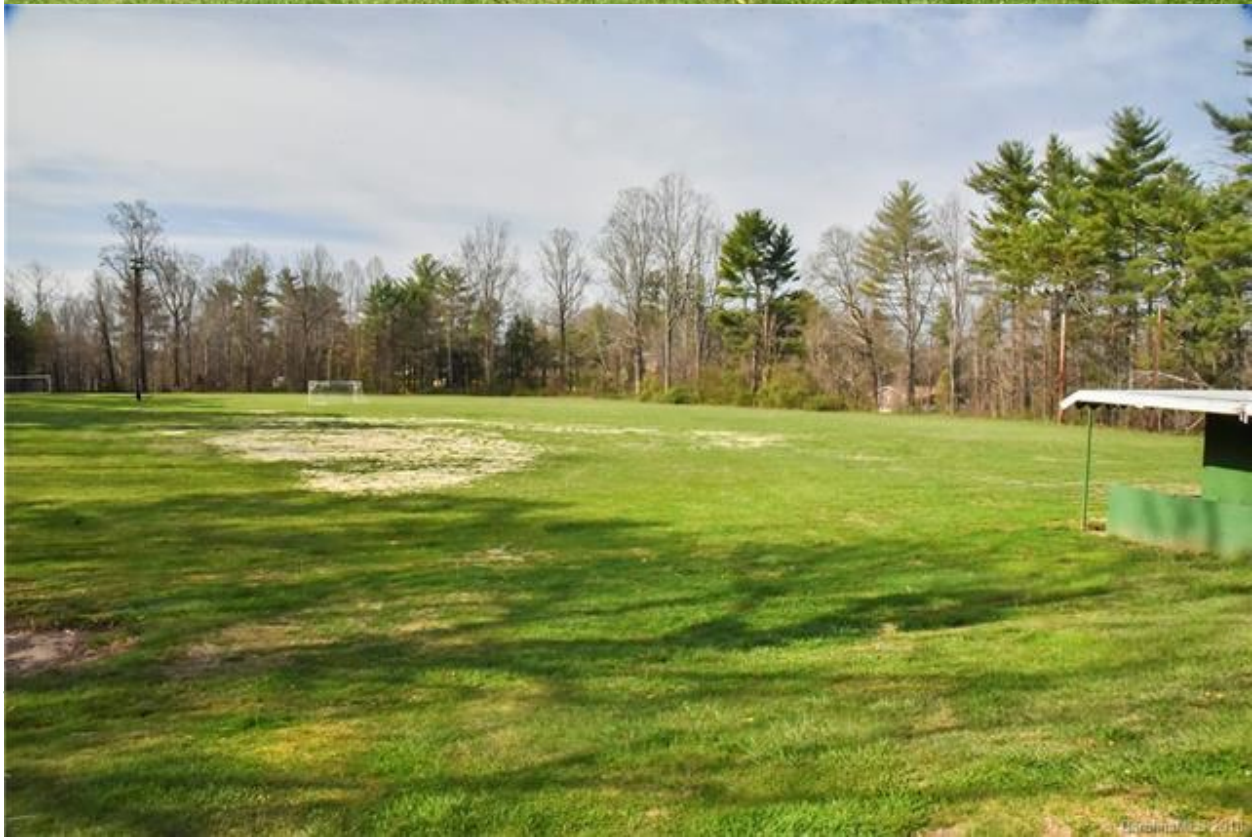
- 1.12 There are several utility outbuildings including a concessions building with bathrooms at the edge of the substantial athletic fields.
